Manhole Inspection Summary

Manhole # S3100_019MH

Insp Date: **4/26/07 11:42 AM**

Location Address: **501 SISSON ST**

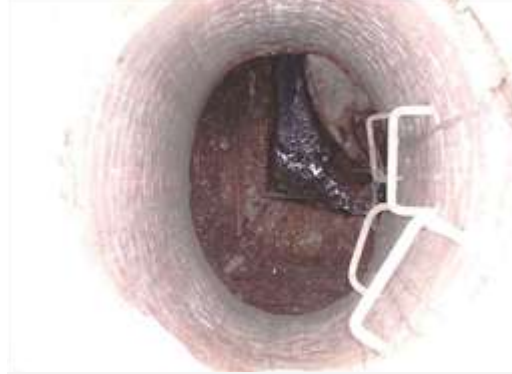
Top View

Corroded steps. Evidence of surcharge - Bench debris. Channel debris.

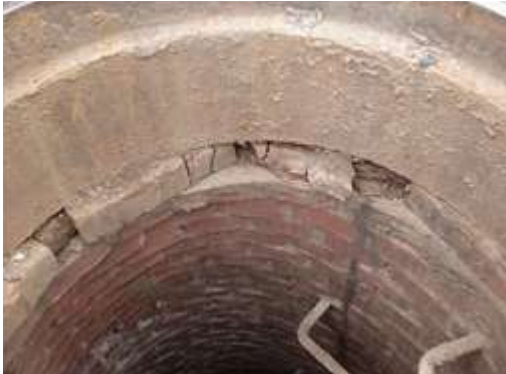
Defect

Frame leaks. Adjustment deterioration, loose brick, cracks and infiltration - other side.

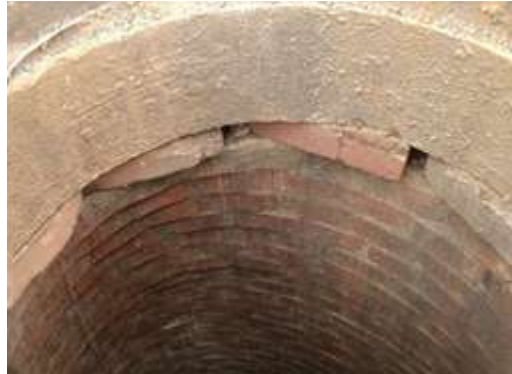
Defect

Frame leaks. Adjustment deterioration, loose brick cracks and infiltration.

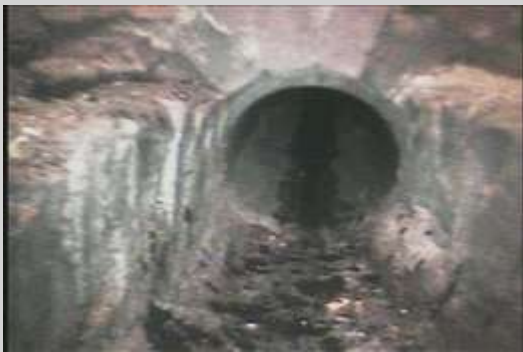
8 in. Circular Gravity Sewer Pipe Out @ 12 O'Clock

Invert Depth: **7.92** (ft.) Flow Characteristics: **Slow**

Deposits: ☒ None ☐ **Mud** ☐ **Grassy** ☐ **Debris** ☐ Grease

Infiltration: **Evidence** Pipe Seal Cond: **Unknown**

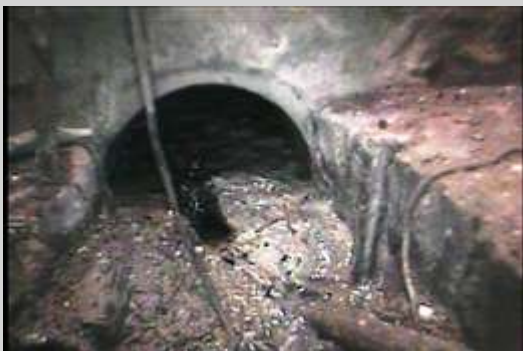
8 in. Circular Gravity Sewer Pipe In @ 4 O'Clock

Invert Depth: **7.60** (ft.) Flow Characteristics: **Slow**

Deposits: ☐ None ☒ **Mud** ☒ **Grassy** ☒ **Debris** ☐ Grease

Silt Depth: **3** (in.) Deposits Extent: **Medium**
